Fossfjörður, Arnarlax hf.  
B-bottom survey,  
June 2020  
(fallow period)

Information client			
Titel	Fossfjörður, Arnarlax hf. B-bottom survey, June 2020		
Report number	APN-62252.B01		
Site name	Fossfjörður	Coordinates site	65°37.864 N 023°32.663 V
County		Municipality	Vesturbyggð
MTB-or estimated max biomass	2.733 tonn	Site manager/contact	Silja Baldvinsdóttir
Client name	Arnarlax hf.

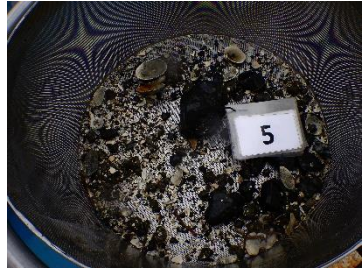
<p><i>St 5</i></p>	<p>NA</p>

Sample number	1	2	3	4	5	6	7	8	9	10
Depth (m)	61	64	65	64	65	65	74	75	75	75
Number of trials	1	2	1	2	3	1	1	2	1	2
Gas bubbles (in sample)	No	No	No	No	No	No	No	No	No	No
Sediment type	Clay	X	X	X	X	X	X	X	X	X
	Silt									
	Sand									
	Gravel					X	X			
	Shellsand		X							
Reef										
Rocky bottom (cobbles, boulders)										
Echinodermata, count		1								
Crustaceans, count										
Molluscs, count			5	4				5	4	
Polychaetes, count	>50	>20	>30	>50	>50	>30	>100	>100	>50	>100
Other animals, count										
<i>Beggiatoa</i>										
Feed										
Faeces										
Comments	Samples at stations 5 and 6 litle washed.									
Grab	Area [m <sup>2</sup> ]	0,1		Grab ID	k-3
