# B-survey at Laugardalur 1, September 2024 (max biomass), Arnarlax ehf

**Akvaplan-niva AS Report:**  
**APN 66115.B01**

Author(s)	Snorri Gunnarsson
Date	25.10 2024
Report No.	APN 66115.B01
Number of pages	18
Distribution	Through customer
Customer	Arnarlax ehf
Contact person	Silja Baldvinsdóttir

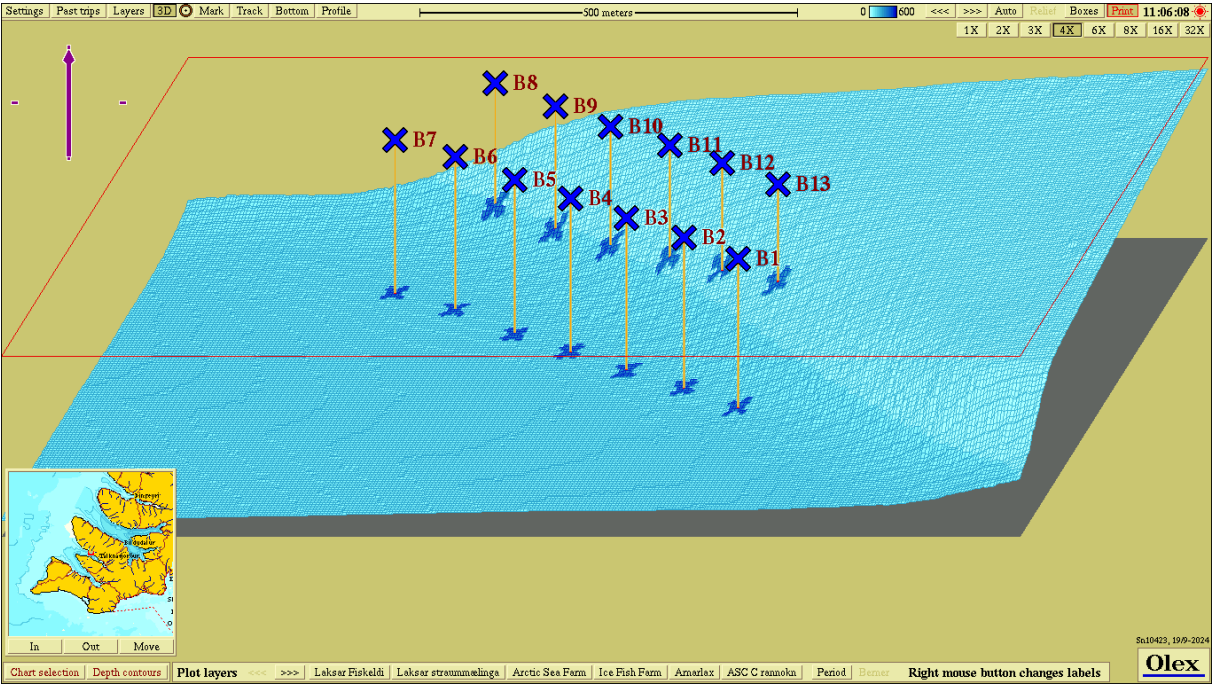
Figure 3. 3D-view of bathymetry at Laugardalur 1 with stations as shown in Figure 2 and Table 4.
