# B-survey at Haukadalsbót, September 2025 (fallow period), Arctic Sea Farm ehf

Akvaplan-niva AS Report: APN 2025 66881.B01

# B survey at Haukadalsbót September 2025 (fallow period), Arctic Sea Farm ehf

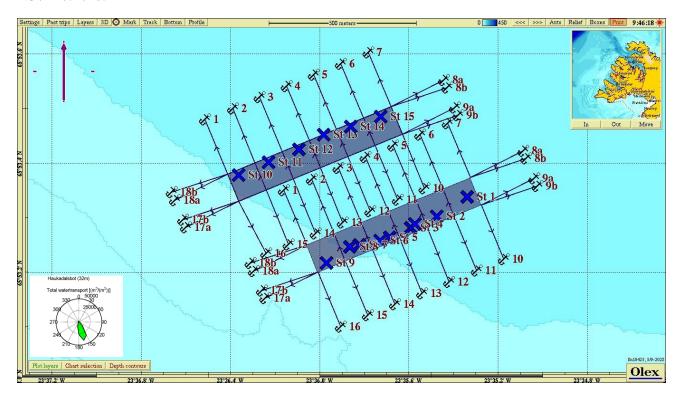
Figure 2. Overview map showing site configuration and local bathymetry at Haukadalsbót. Sampling stations are marked by crosses and colour coded to visualise the environmental status at the respective station following the classification outlined in NS 9410:2016, chapter 7.11 (1 = blue, 2 = green, 3 = yellow, 4 = red). The current rose in the right corner shows the direction of water transport, and the red flag indicates placement of current meter for measuring dispersal current (Gustavsson, 2019).

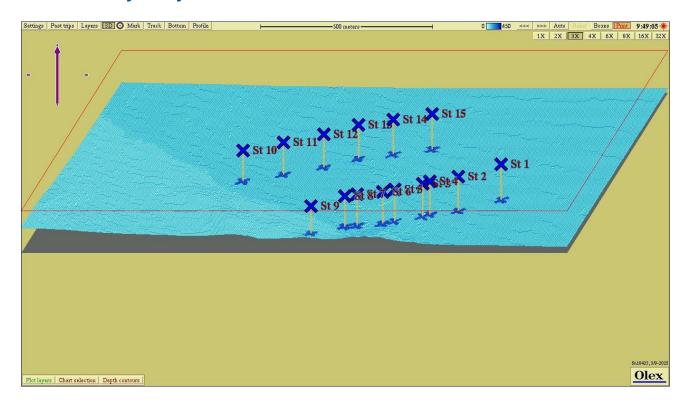
Figure 3. 3D-view of bathymetry at Haukadalsbót with stations as shown in Figure 2 and Table 4. The map is oriented towards the north.
