# **B-survey at Steinanes, August 2025 (max biomass), Arnarlax ehf**

**Akvaplan-niva AS Report:  
APN 2025 66876.B02**

| Report No. | APN 2025 66876.B02 |

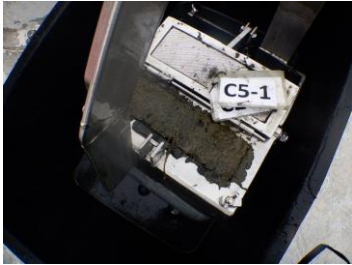
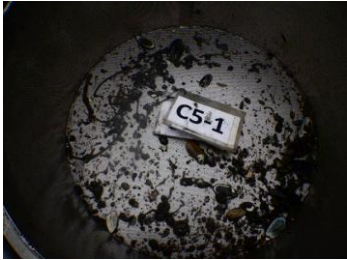
| <i>St</i> | <i>Image before sieving</i> | <i>Image after sieving</i> |
|---|---|---|
| <i>St 1</i> | | |

| Comments | | St- 1; 4-6; Some dead broken shells in sample. | | | | | | | | | |
