Arnarnes, Arctic Sea Farm B-bottom survey, September 2021 (pre study)

Information client										
Title	Arnarnes, Arctic Sea Far	m. B-bottom survey (pre	study), September 2021							
Report number	APN-63465.B01	PN-63465.B01								
Site name	Arnarnes	Coordinates site	66°06,585N 023°00,041V							
County	Ísafjarðarsýsla	Municipality	Ísafjarðarbær							
MTB-or estimated max biomass	5.500 tonnes	Site manager/contact	Steinunn Guðný Einarsdóttir							
Client name	Arctic Sea Farm

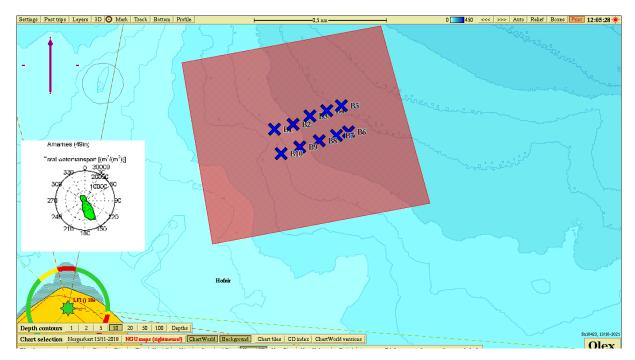
Measurement of dispersing current was done at the site in April – May 2021 measurements at 49 m depth (Gustavsson, 2021). Dominating current at 49 m is in direction south by south-east (165 degrees) with a small counter current in opposite direction (Figure 2). Average current speed is measured to be 5.7 cm/s. Highest current speed is measured to be 31.3 cm/s and 4.2 % of the measurements are < 1 cm/s.

Position of the 10 stations in the survey is given in Figure 2 and Table 2. Positioning of the stations was chosen based on guidance and criteria described in NS 9410:2016 and spread around the periphery of the cages (as cage setup is planned). At the site the typical depth in the local impact zone is in the range from 48 - 72 m, with an increasing depth on northern part of the mooring frame. The placement of sampling stations was chosen to give a good picture of the condition of the whole local impact zone. It is important to evaluate the status in both the deeper and shallower parts of the local impact zone of the fish farm. The sampling stations had a depth varying from 48 to 71 m. The placement of the sampling stations is regarded to be in accordance with the descriptions for survey of local impact zone given in NS 9410:2016.

Figure 2. Chart showing Arnarnes site. Sampling stations st. 1-10 are marked with color codes that describe the group II and III condition according to NS 9410:2016, chapter 7.11. Color codes: Blue = very good condition, green = good condition, yellow = bad condition, red = very bad condition.

For the group II parameters (pH/Eh), all stations had conditions 1 «very good». For sensory parameters (group III) all ten stations had condition 1 «very good», see Table 1. For combined parameters II and III (pH/redox and sensory) all ten stations received status 1 «very good», see Figure 2. Animals where present in all the ten samples, polychaetes and molluscs were most prominent.

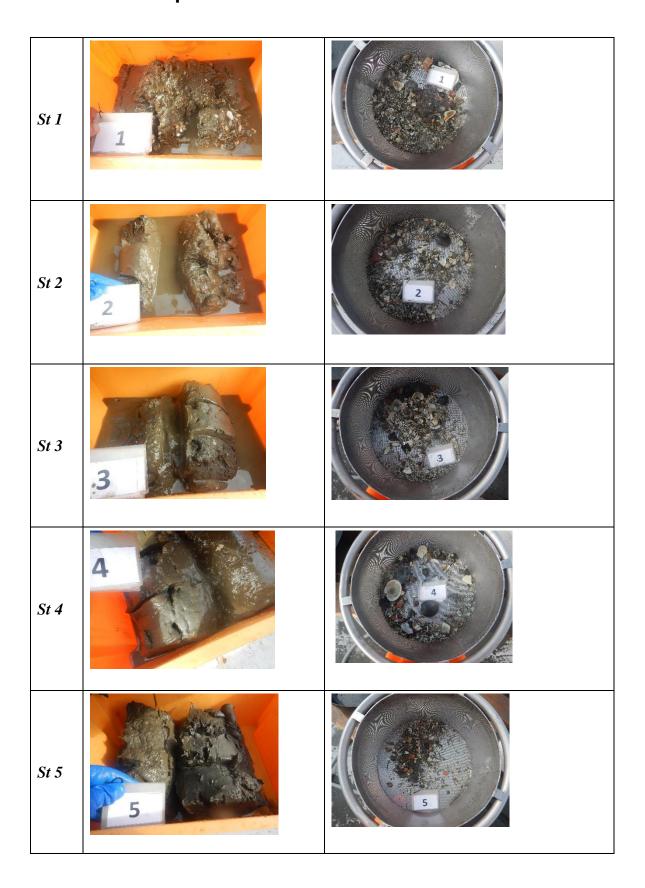
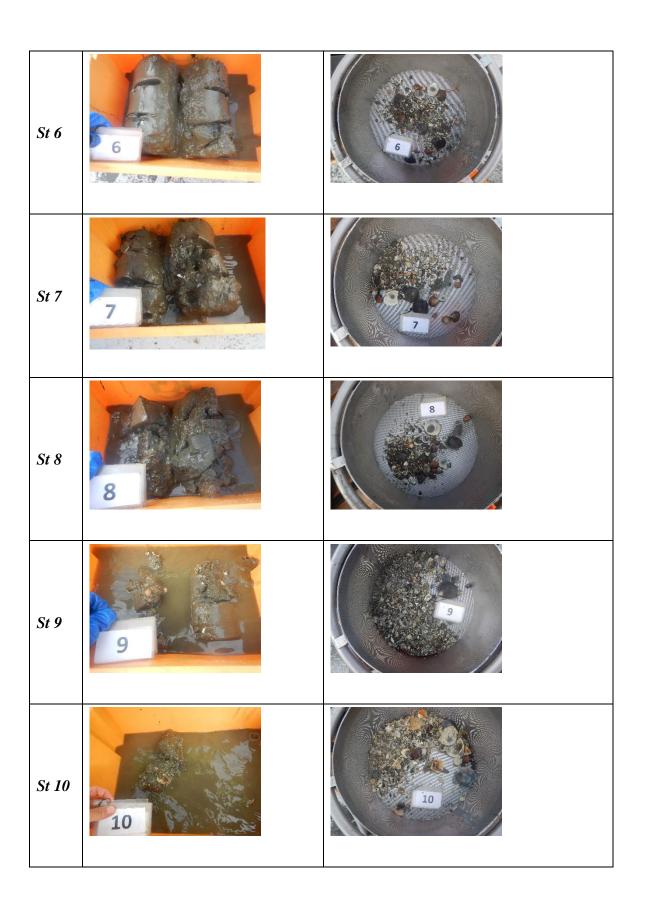
7.2 Pictures of samples at Arnarnes

There were collected valid sediment samples at all the ten sampling stations. This indicates that in general there is soft bottom in the local impact zone. The sediment type consisted mainly of clay and silt at greater depths while sand and gravel were more prominent at shallower depths. This indicates harder bottom type closer to shore, at shallower depth.

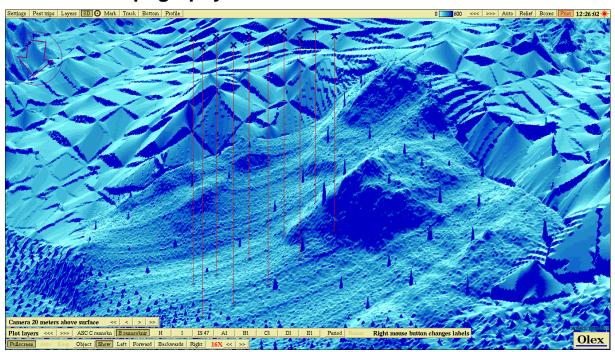
Figure 3. Showing bottom topography 3D at Arnarnes with each sampling station according to info in Figure 1 and Table 2.
