Eyrarhlíð 2, Arctic Sea Farm ehf.
B-bottom survey,
March 2022
(maximum biomass survey)

Information client			
Titel	Eyrarhlíð 2, Arctic Sea Farm ehf. B-bottom survey, March 2022 (maximum biomass survey)		
Report number	APN-63863.B01		
Site name	Eyrarhlíð 2	Coordinates site	65°55.489 N 23°43.504 V
County		Municipality	Ísafjarðarbær
MTB-or estimated max biomass	5069 ton	Site manager/contact	Steinunn G. Einarsdóttir
Client name	Arctic Sea Farm ehf.

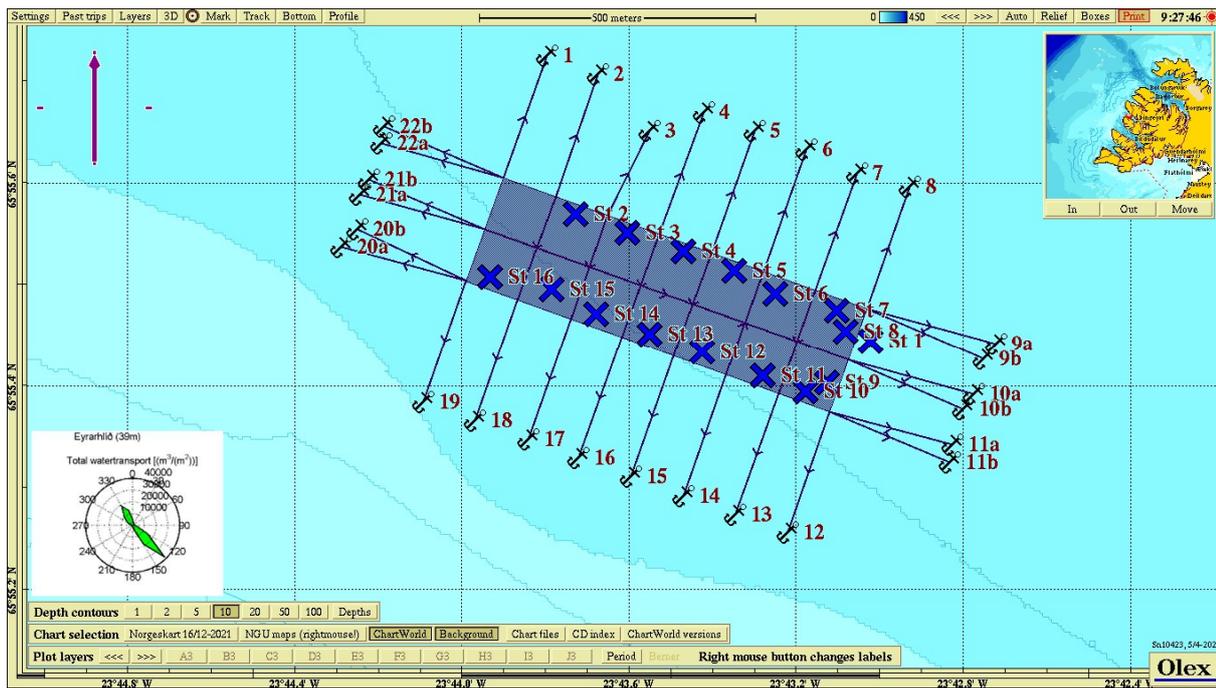
Figure 2. Chart showing depths at the site Eyrarhlíð 2. Sampling stations st. 1 – 16 are marked with color codes that describe the condition according to NS 9410:2016, chapter 7.11. Color codes: Blue = very good condition, green = good condition, yellow = bad condition, red = very bad condition. The spread current at 39 m depth is shown in lower left corner (Gustavsson, 2019).

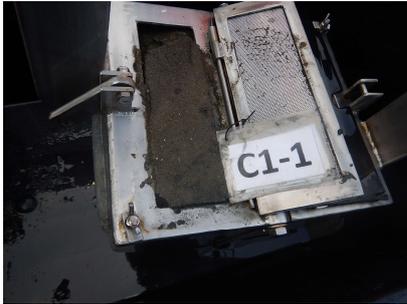
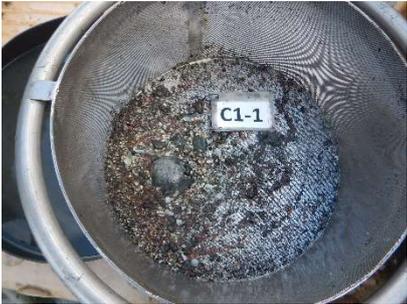
<i>St 1</i>

<p>A white rectangular tray containing a dark, granular sediment sample. A small white label with the text 'C1-1' is placed on the right side of the tray.</p>

<p>A circular sieve containing the sediment sample from St 1. A small white label with the text 'C1-1' is placed in the center of the sieve.</p>
<i>St 2</i>

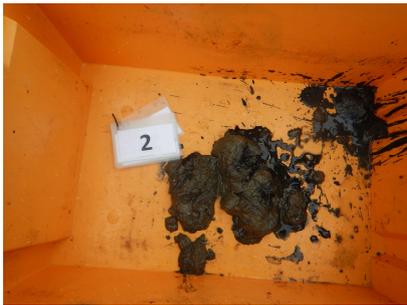
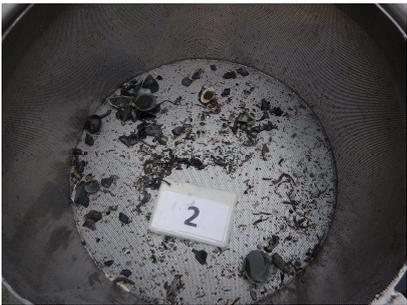
<p>A yellow rectangular tray containing a dark, clumpy sediment sample. A small white label with the text '2' is placed on the left side of the tray.</p>

<p>A circular sieve containing the sediment sample from St 2. A small white label with the text '2' is placed in the center of the sieve.</p>
<i>St 3</i>

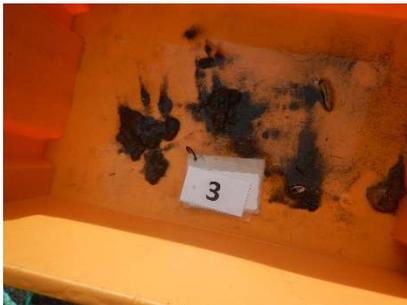
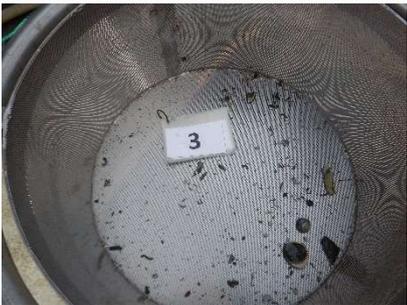
<p>A yellow rectangular tray containing a dark, clumpy sediment sample. A small white label with the text '3' is placed in the center of the tray.</p>

<p>A circular sieve containing the sediment sample from St 3. A small white label with the text '3' is placed in the center of the sieve.</p>

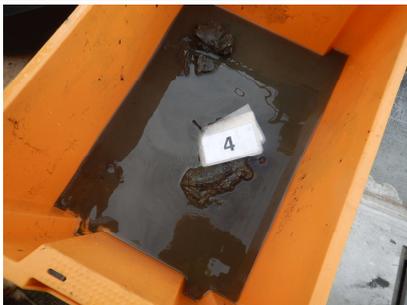
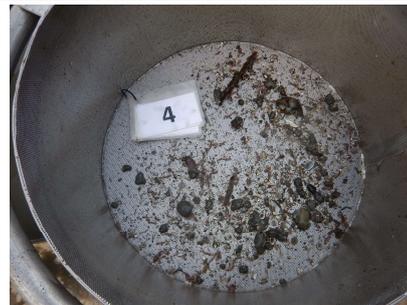
<i>St 4</i>

<p>A yellow rectangular tray containing a dark, clumpy sediment sample submerged in water. A small white label with the text '4' is placed in the center of the tray.</p>

<p>A circular sieve containing the sediment sample from St 4. A small white label with the text '4' is placed in the center of the sieve.</p>
<i>St 5</i>

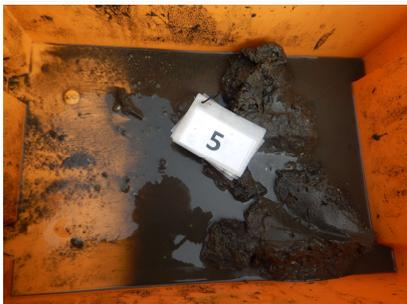
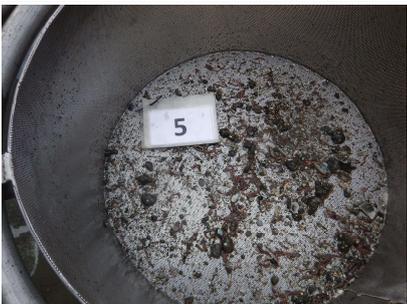
<p>A yellow rectangular tray containing a dark, clumpy sediment sample submerged in water. A small white label with the text '5' is placed in the center of the tray.</p>

<p>A circular sieve containing the sediment sample from St 5. A small white label with the text '5' is placed in the center of the sieve.</p>

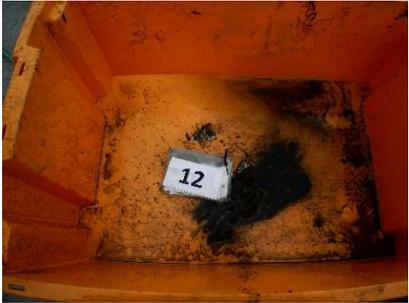
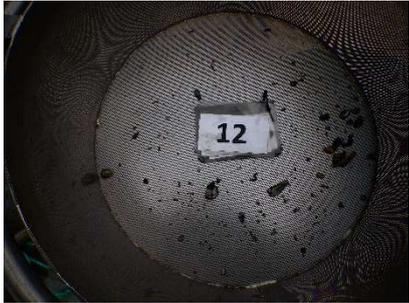
<p><i>St 12</i></p>

There were collected valid sediment samples at all the sixteen sampling but at one of the sampling stations (st. 12) group II parameters (pH/Eh) could not be measured due little sample in the grab but sensory analysis was possible. This indicates that most of the local impact zone is soft bottom. In general the sediment type consisted mainly of fine clay but clay with mixture of sand was more common in the western part of the local impact zone.

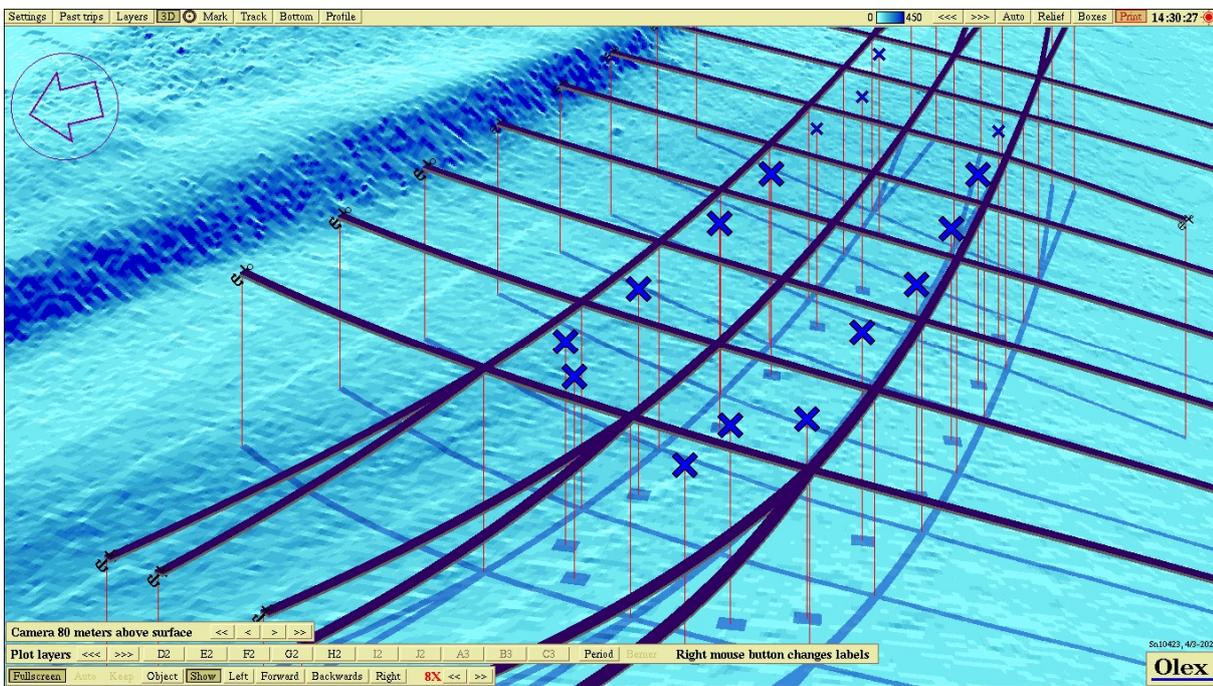
Figure 3. Showing bottom topography 3D at Eyrarhlíð 2 with each sampling station according to info in figure 2 and Table 3.
