Gemlufall, Arctic Sea Farm
B-bottom survey,
July 2021
(maximum biomass survey)

Akvaplan-niva AS: APN 63341.B01

| Information client | | | |
|---|--|---|---|
| Title | Gemlufall, Arctic Sea Farm. B-bottom survey, July 2021 | | |

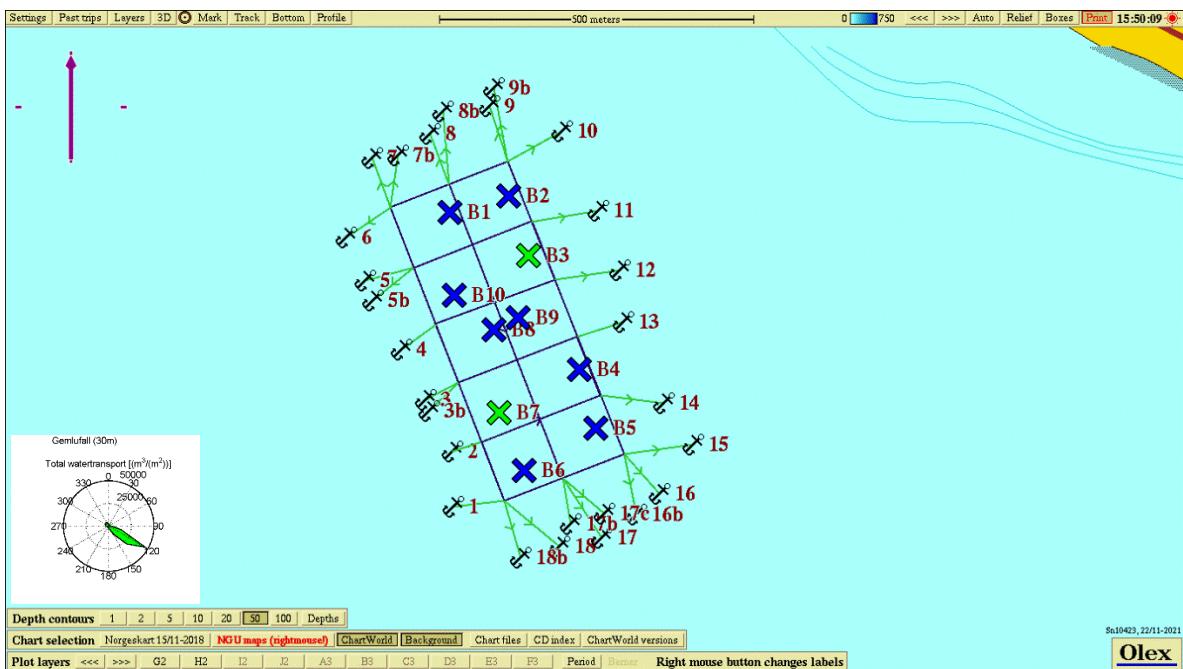
Positioning of the stations was chosen based on guidance and perimeters described in NS 9410:2016 and spread around the periphery of the cages. Gemlufall site is close to the center of Dýrafjörður and the site is well sheltered. At the Gemlufall site the typical depth in the local impact zone is in the range from 28 – 32 m, with very little slope and slightly less depth in north part of the farming area. The placement of sampling stations was chosen to give a good picture of the condition of the whole local impact zone. It is important to evaluate the status in both the deeper and shallower parts of the local impact zone of the fish farm. The sampling stations had a depth varying from 28 to 31 m. The placement of the sampling stations is regarded to be in accordance with the descriptions for survey of local impact zone given in NS 9410:2016.

Figure 2. Chart showing depths at the site Gemlufall. Sampling stations st. 1 – 10 are marked with color codes that describe the condition according to NS 9410:2016, chapter 7.11. Color codes: Blue = very good condition, green = good condition, yellow = bad condition, red = very bad condition.

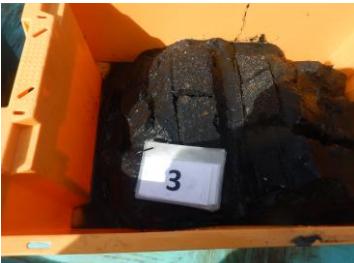
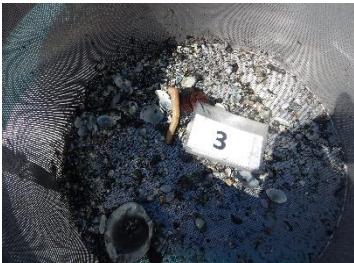
| <i>St 3</i> | | |

For combined parameters II and III (pH/redox and sensory) eight stations had condition 1 «very good» and two stations had condition 2 «good» (stations 3 and 7). The stations with condition 2 «good» were located at the north-eastern (St. 3) and south-western (St. 7) part of the fish farming area. Highest biomass and feeding during the current generation was in the six cages in the northern part of the farming area so the highest organic load in the local impact zone is coherent with the layout of these and the direction of spread current of the site (to south-east). Animals were present in all soft bottom samples. The previous B bottom survey at fallow before putting smolt into sea gave also overall condition 1 «very good». The current results indicate some slight increase in organic load at the site compared to results from the fallow survey in May 2020. The short production period (about 1 year) at the site for the current generation should however be pointed out (salmon to be moved to another site in July 2021).

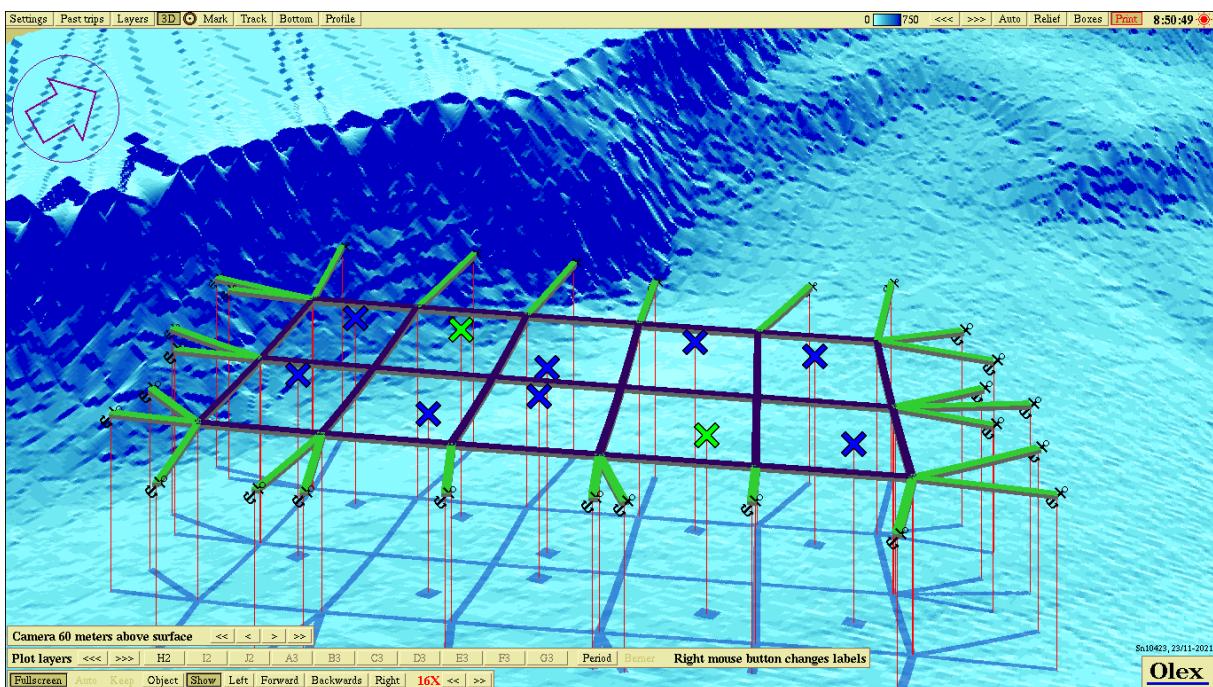
Figure 3. Showing bottom topography 3D at Gemlufall with each sampling station according to info in figure 2 and Table 3.
